## New Samaritan hospital coming to Lincoln City

**PROJECT UPDATE:** Oct. 1, 2018  
Issue No. 34

### From sky high to underground

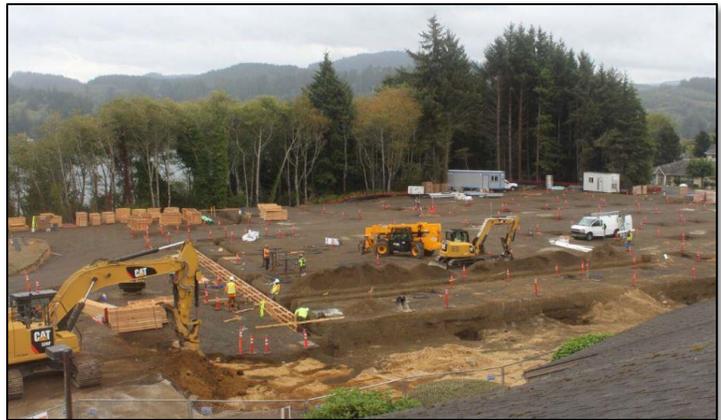
So far, each steel pile has been cut down to ground level, lined with an interior rebar cage and filled with concrete. The concrete boxes that will cap the piles have been poured and wood forms are being built for the concrete grade beams. Ultimately, concrete slabs that will make up the floor of our new building will be created with four massive cement pours. Projected timeline to complete the foundation is two to three months, depending on cooperation from the weather. *In photo below, you can see forms for the foundation being built along the north edge of the building.*
