Hallux Valgus Correction Using a Novel 3D Printed Plate: Retrospective Case Series with Two Year Follow-up Data. Surgical Technique Guide and Outcomes.

Justin Brohard DO, Ryan Callahan DO, Jason Lin MD

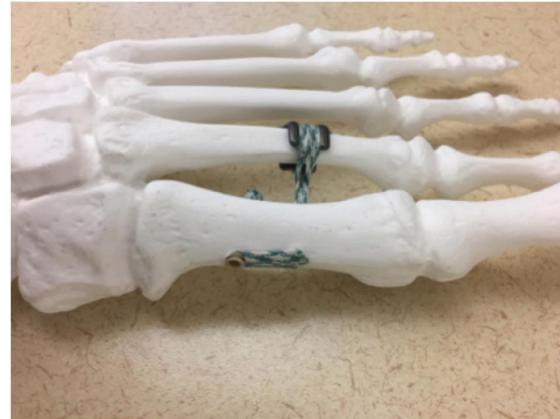
Medial to lateral view of the FastForward device implanted on a plastic foot skeleton model. The plate on the second metatarsal does not require drilling or cutting the bone as it is held in place with the looped suture tape. The first metatarsal is fixated with two drill holes and interference screws holding the suture tape under tension.

- Dual dorsal/medial incision; Modified McBride performed in standard fashion
- FastForward plate on lateral aspect of second metatarsal shaft. FiberTape looped around/through plate. Reduction of 1-2 intermetatarsal space by manual pressure or reduction clamp. FiberTape passed through two drill holes in first metatarsal shaft and held under tension with interference screw fixation.

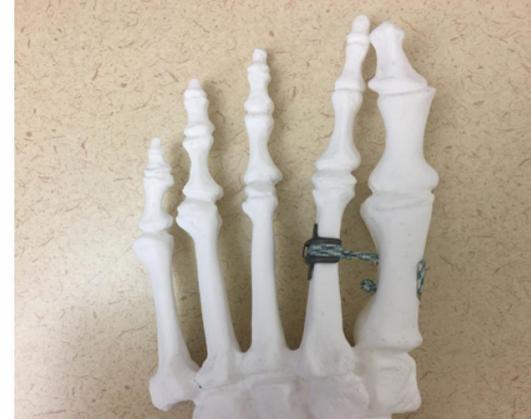
Dorsal view of the FastForward device implanted on a plastic foot skeleton model. The tension on the suture tape is used to hold the reduction of the 1-2 interspace after bunionectomy. This is performed with a two-incision technique approaching the second metatarsal from a dorsal approach and the first metatarsal from a medial approach.

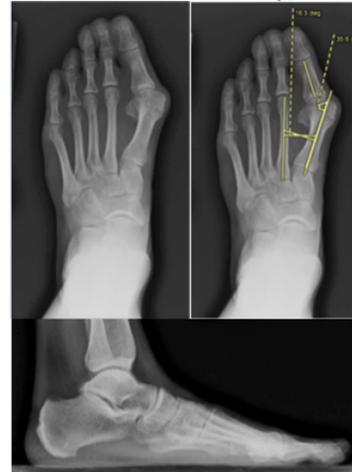
Case 1 – 60 year old female
Pre-op IMA 16.5°; HVA 35.6°
Sx: FastForward, Bunionectomy, Akin

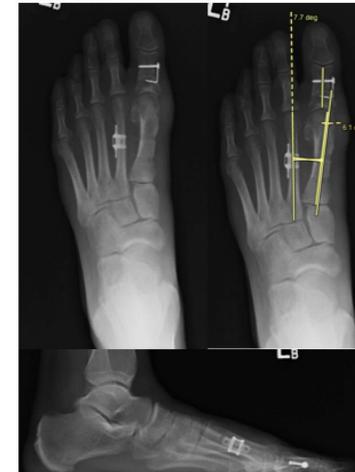
Post-op IMA 7.7°, HVA 6.1°
Good Initial Correction

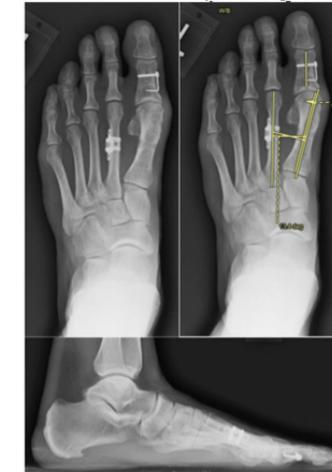
Final follow-up IMA 13.4°; HVA 15.5°
Mild recurrent deformity, no complications

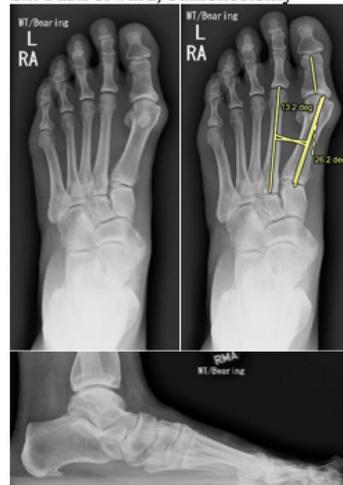
Case 2 – 45 year old female
Pre-op IMA 13.2°; HVA 26.2°
Sx: FastForward, bunionectomy

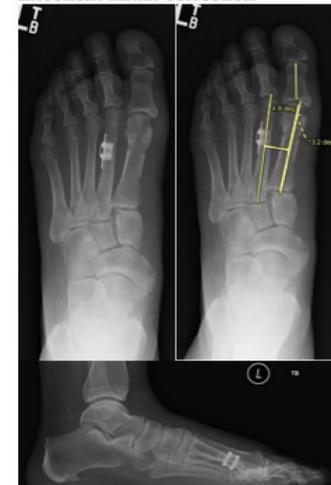
Post-op IMA 4.8°, HVA 13.2°
Excellent initial correction

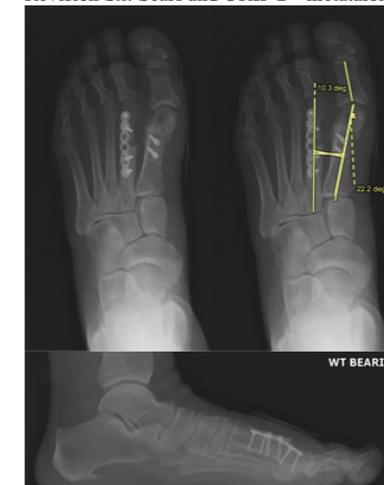
Final follow-up IMA 10.3°, HVA 22.2°
Complication: 2nd metatarsal stress fracture
Revision Sx: Scarf and ORIF 2nd metatarsal
